Complex environmental cleanup restores valuable intertidal habitat at former mine site

- The Port of Tacoma, Washington, had to remediate and restore the extremely contaminated site of a former gravel mine and landfill. Investigations revealed that contaminants had entered the underlying groundwater and threatened to harm aquatic life in nearby Hylebos Creek.

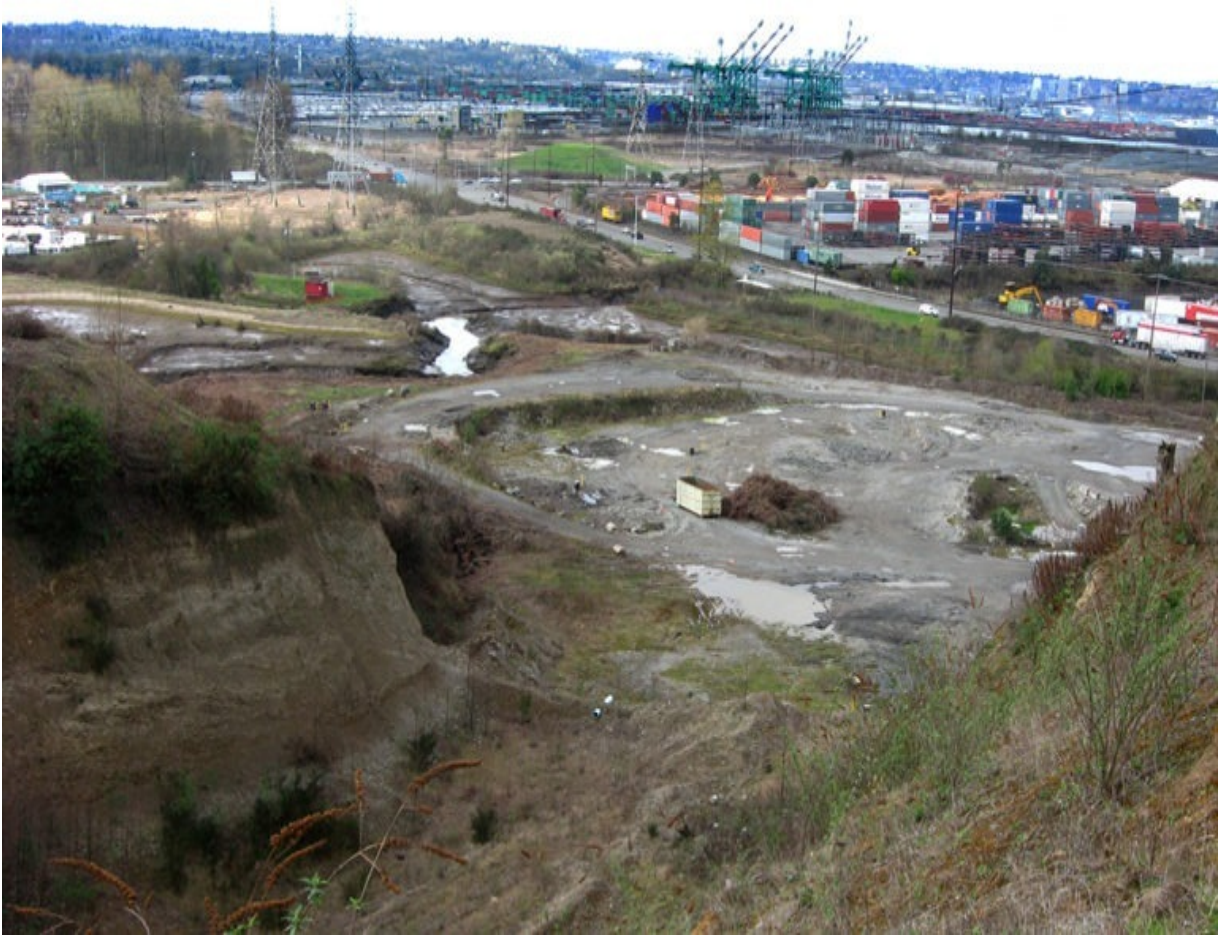
Site prior to construction. The project represents the Port of Tacoma's largest habitat restoration.

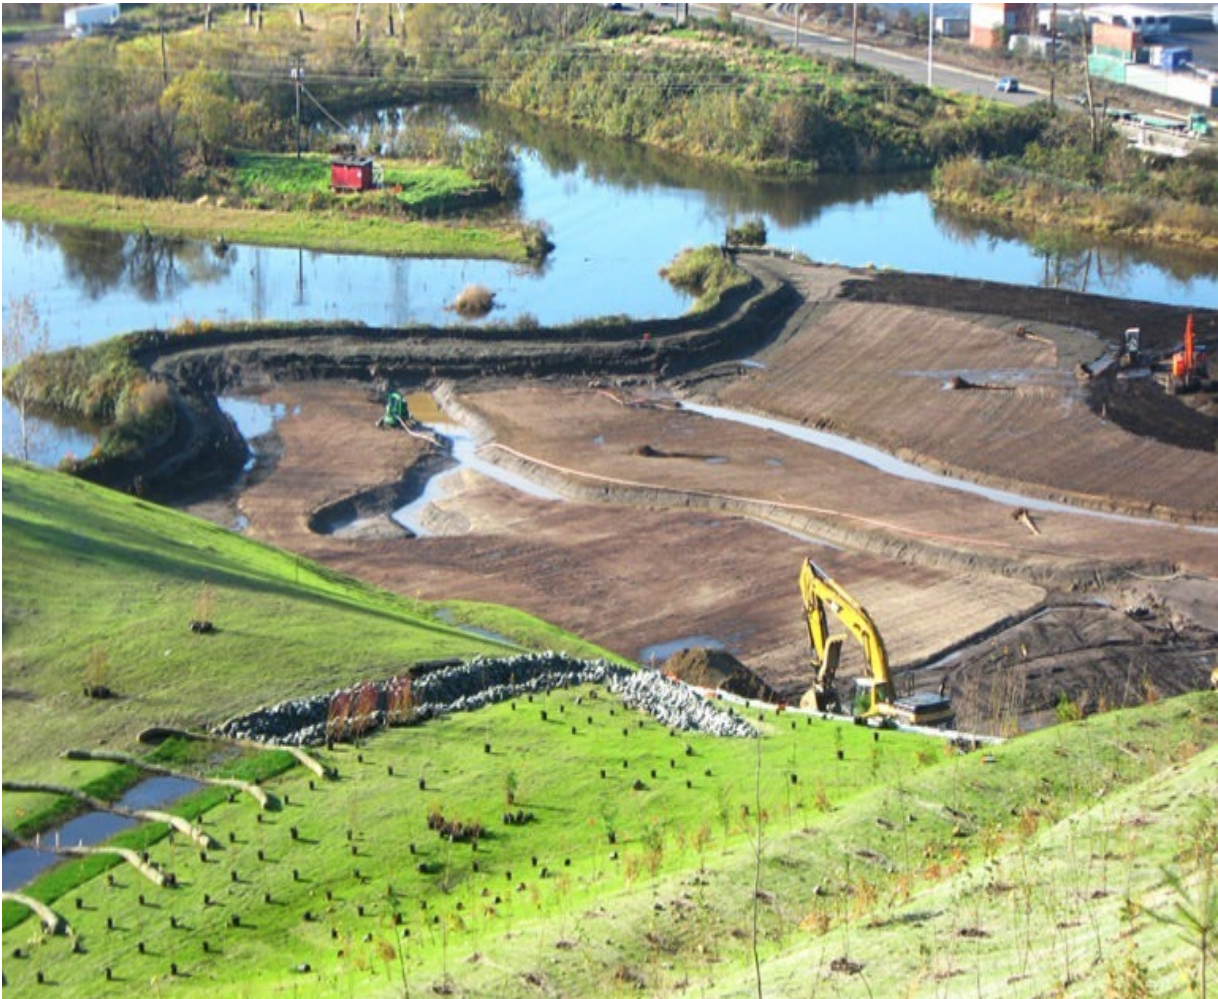
At high tide, water flows from the creek into the newly created intertidal zone and stream channels, creating resting and feeding areas for juvenile salmon as well as habitat for native plants, water birds, and other wildlife. The Puyallup Tribe of Indians named it "kal'-ka-lukw-al-kwo," which means "Place of Circling Waters."
